Performance Label Material Guide for Identifying Rotary Diecutting Problems

Technical Bulletin

November, 2007

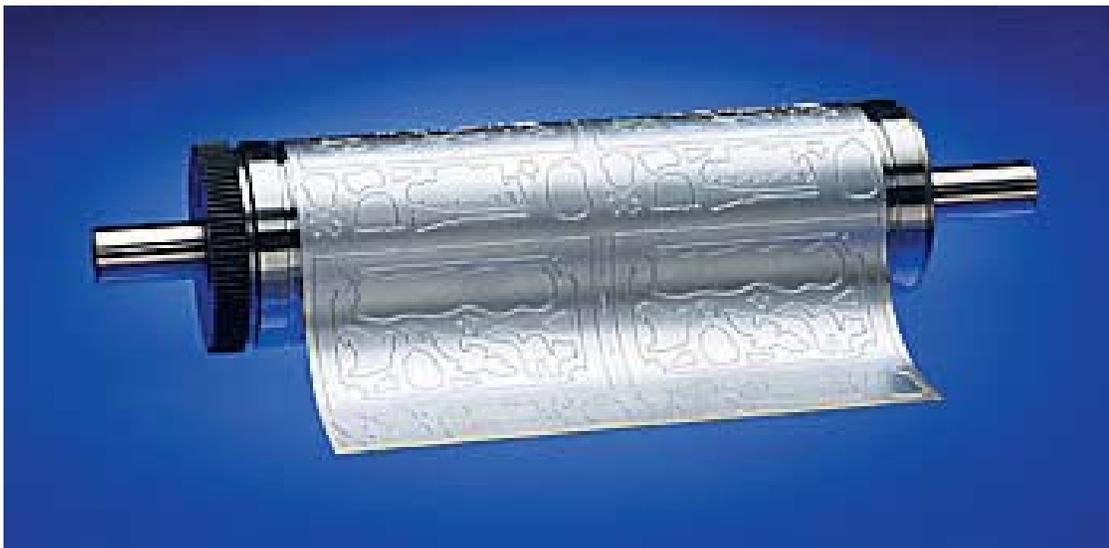
1) **Flexible Dies - (Mag Dies)**

- a. These are thin flexible steel plates with the cutting edges machined into them. These are mounted to a magnetic cylinder. Magnetic dies are used for relatively short runs and have a limited service life. Cost is significantly less than traditional rotary dies.

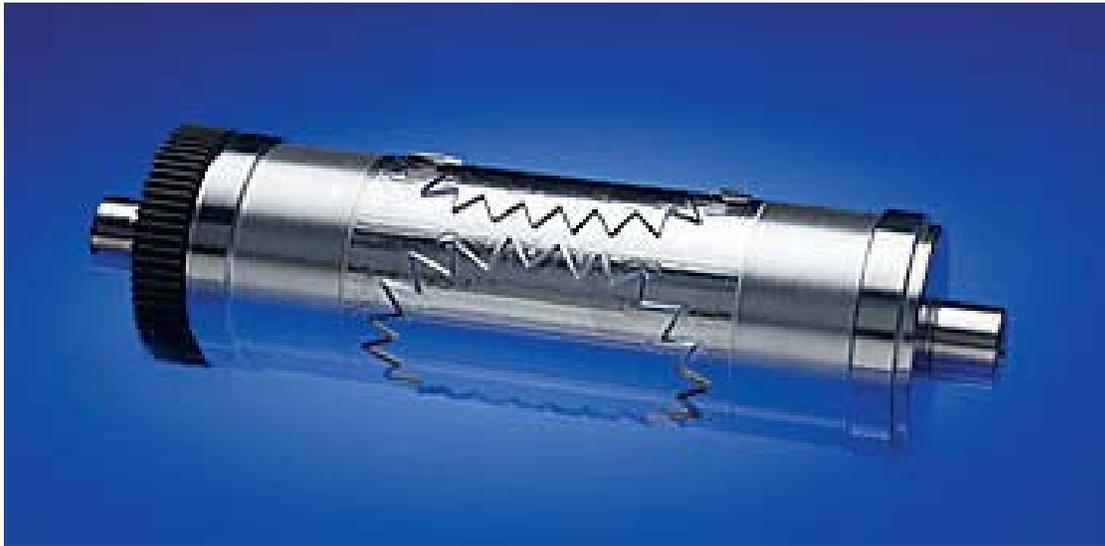
2) **Standard Rotary Tooling**

- a. This is the standard machined tooling and is generally used for longer runs as it has a longer service life than the flexible tooling, but the costs are higher.
